PRELIMINARY INVESTIGATION IN J33 TURBOJET ENGINE OF SEVERAL  
ROOT DESIGNS FOR CERAMAL TURBINE BLADES

By George C. Deutsch, Andre J. Meyer, Jr.  
and William C. Morgan

Lewis Flight Propulsion Laboratory  
Cleveland, Ohio

January 26, 1953

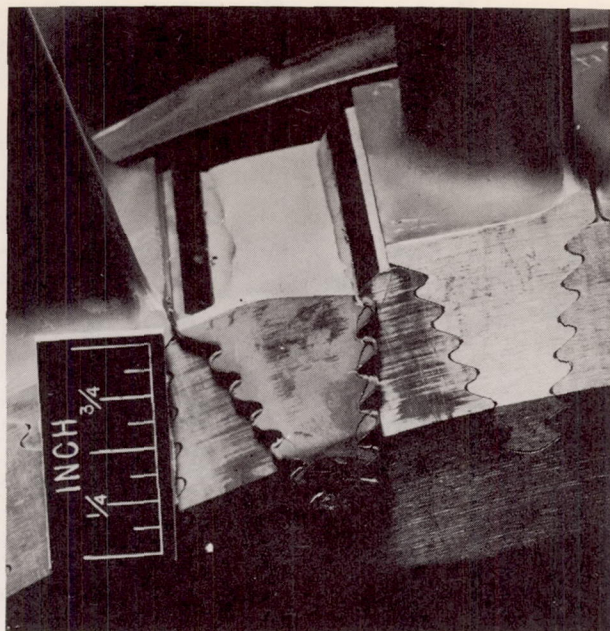
not appear so sound as the blade used in run 4. Figures 3 and 4 indicate the type of failures encountered with this type of root.

Figure 3. - Failure of ceramal blades having fir-tree root after 3 hours and 21 minutes of operation. Failure occurred at 10,900 rpm.

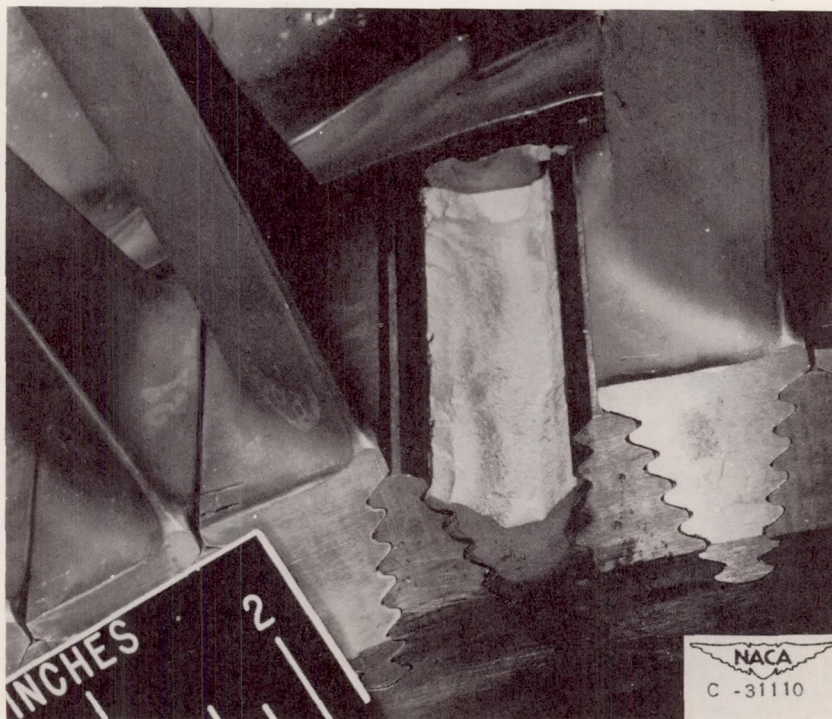
Figure 4. - Failure of ceramal blades having fir-tree root after 2 hours and 23 minutes of operation. Failure occurred at 9000 rpm.

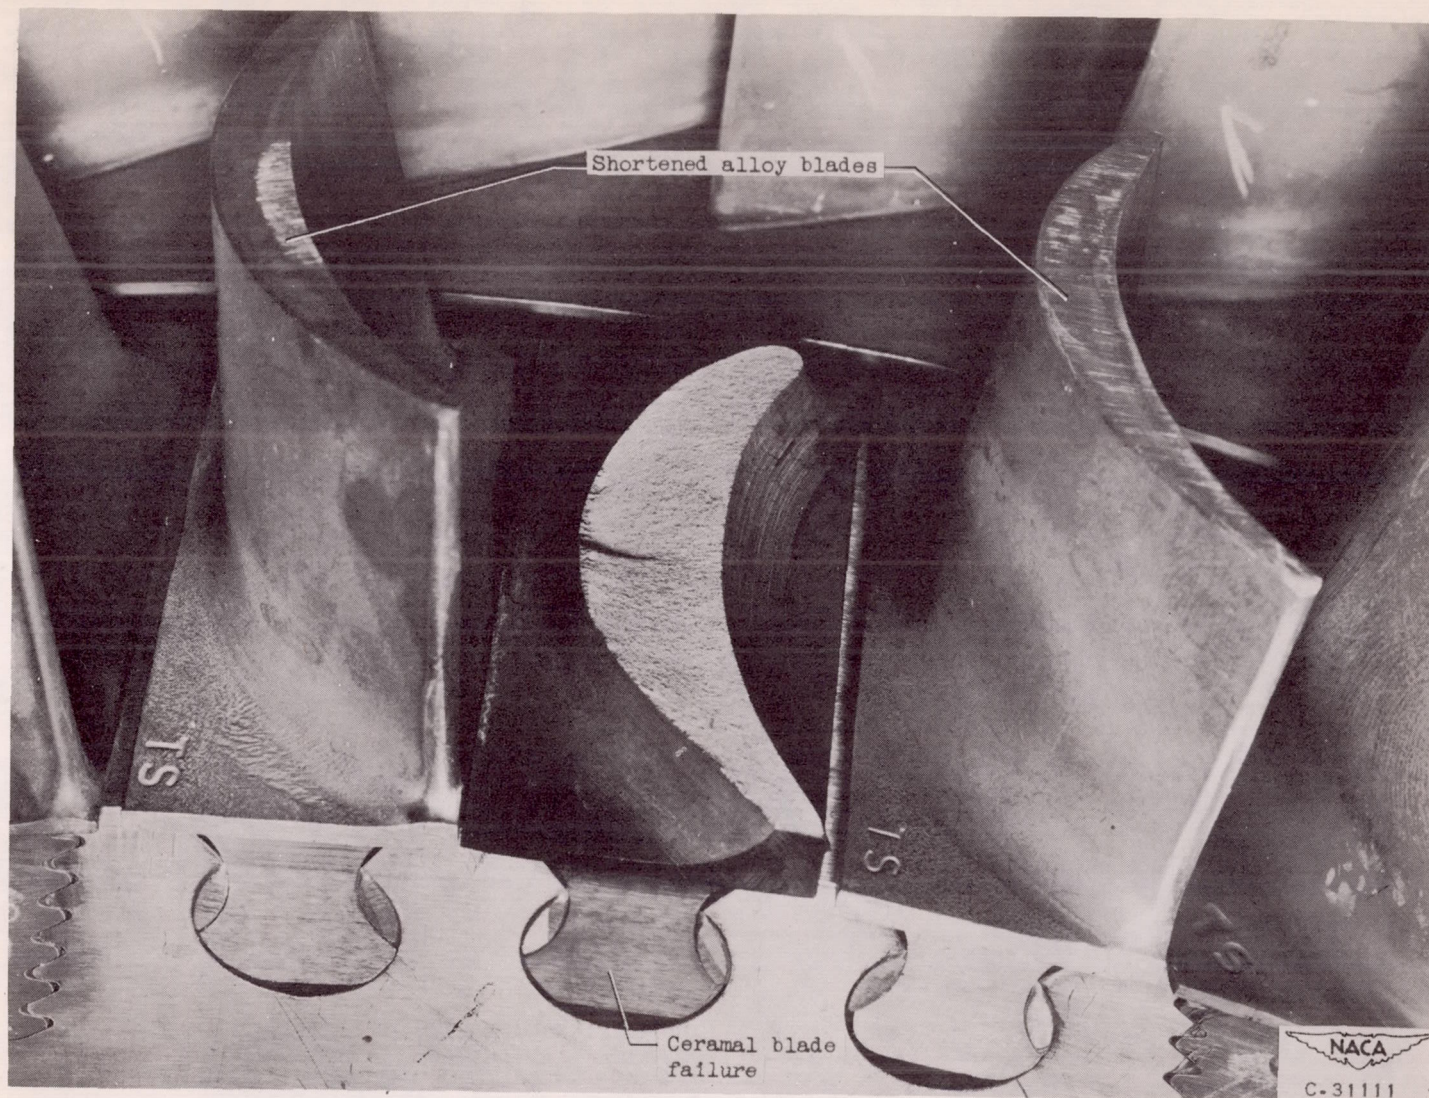
Interlock blade runs. - Runs 5 and 6 each used a single ceramal blade with two adjacent shortened alloy blades and three shortened alloy blades at diametrically opposite positions in the wheel. The gaps left in the wheels by these shortened blades apparently caused a major disturbance in the normal vibration characteristics of the engine because in each case unusually severe vibrations occurred which resulted in severe damage to the struts supporting the "bullet" in the tailcone. After run 5 these struts had a large number of cracks which were repaired by welding. After run 6 the damage was even more extensive and the struts collapsed. While it appears probable that this severe vibration caused the blade airfoil failures, the alloy blades in the remainder of the wheel experienced no apparent damage under the same conditions. A ceramal failure in these runs is shown in figure 5.

Figure 5. - Failure of ceramal blade having interlock root due to severe engine vibration.

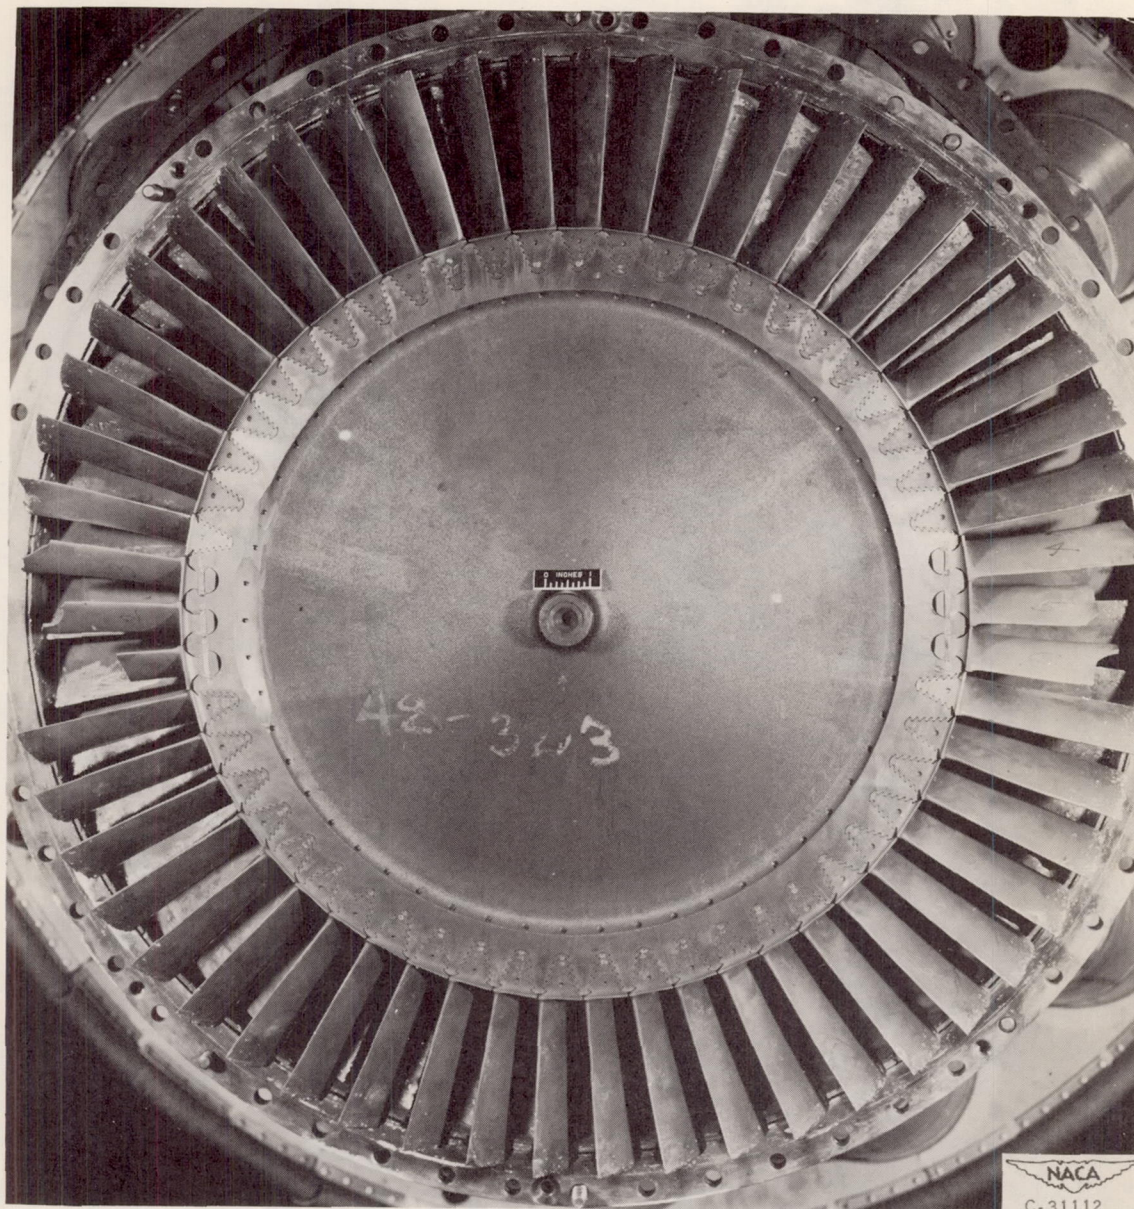
Run 7 utilized six ceramal blades and was an attempt to correct the vibration conditions of the two previous runs. The appearance of the failure (fig. 6) indicates that the first blade to fail was the one in which half the airfoil is missing. The remainder of the failures appear to have resulted from impact by fragments from the first failure. Microscopic examination of the blade that is presumed to have failed first did not reveal any defect in this blade.

During disassembly of the engine after runs 5, 6, and 7, it was noted that several of the combustion-chamber-liner positioning pins had also failed. If these failed prior to the blade failure and then passed through the turbine, their impact with the blades could account for the comparatively low time of operation of these runs.

Figure 6. - Failure of ceramal blades having interlock roots after 1 hour and 10 minutes of operation. Failure occurred at 11,370 rpm.

Run 10 was intended to avoid the probable causes of failures in runs 5, 6, and 7. The blade was made more resistant to vibration by thickening the airfoil. The combustion-chamber-liner positioning pins were strengthened.

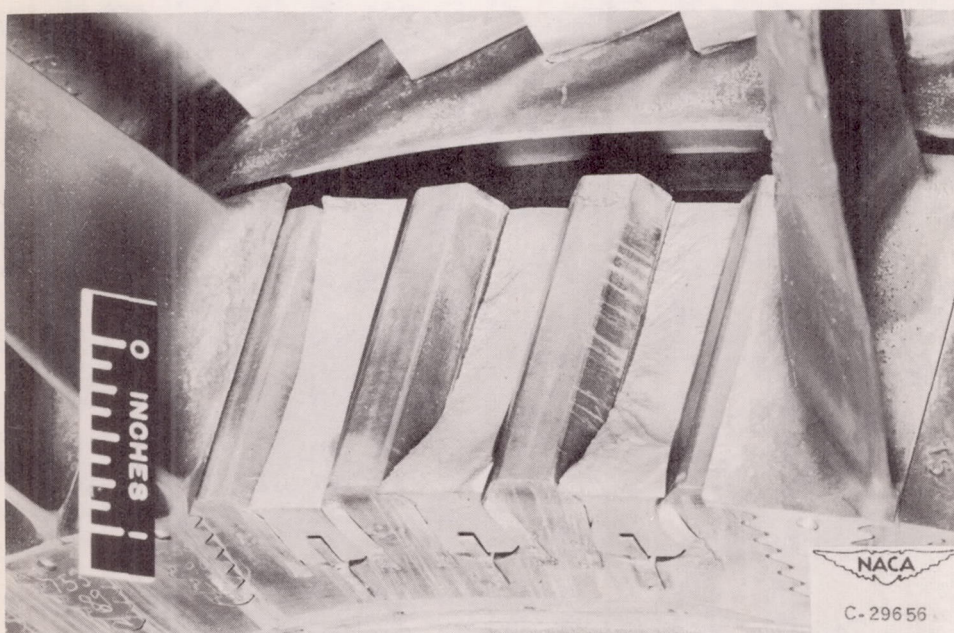
After 68 hours and 23 minutes at rated speed, failure occurred. Three of the blades on one side of the wheel failed in the root (fig. 7) while the three opposing blades (fig. 8) suffered relatively little damage. No cause for the failures could be ascertained.

Figure 7. - Failure of ceramal blades having interlock roots after 68 hours and 28 minutes of operation. Failure occurred at rated speed.

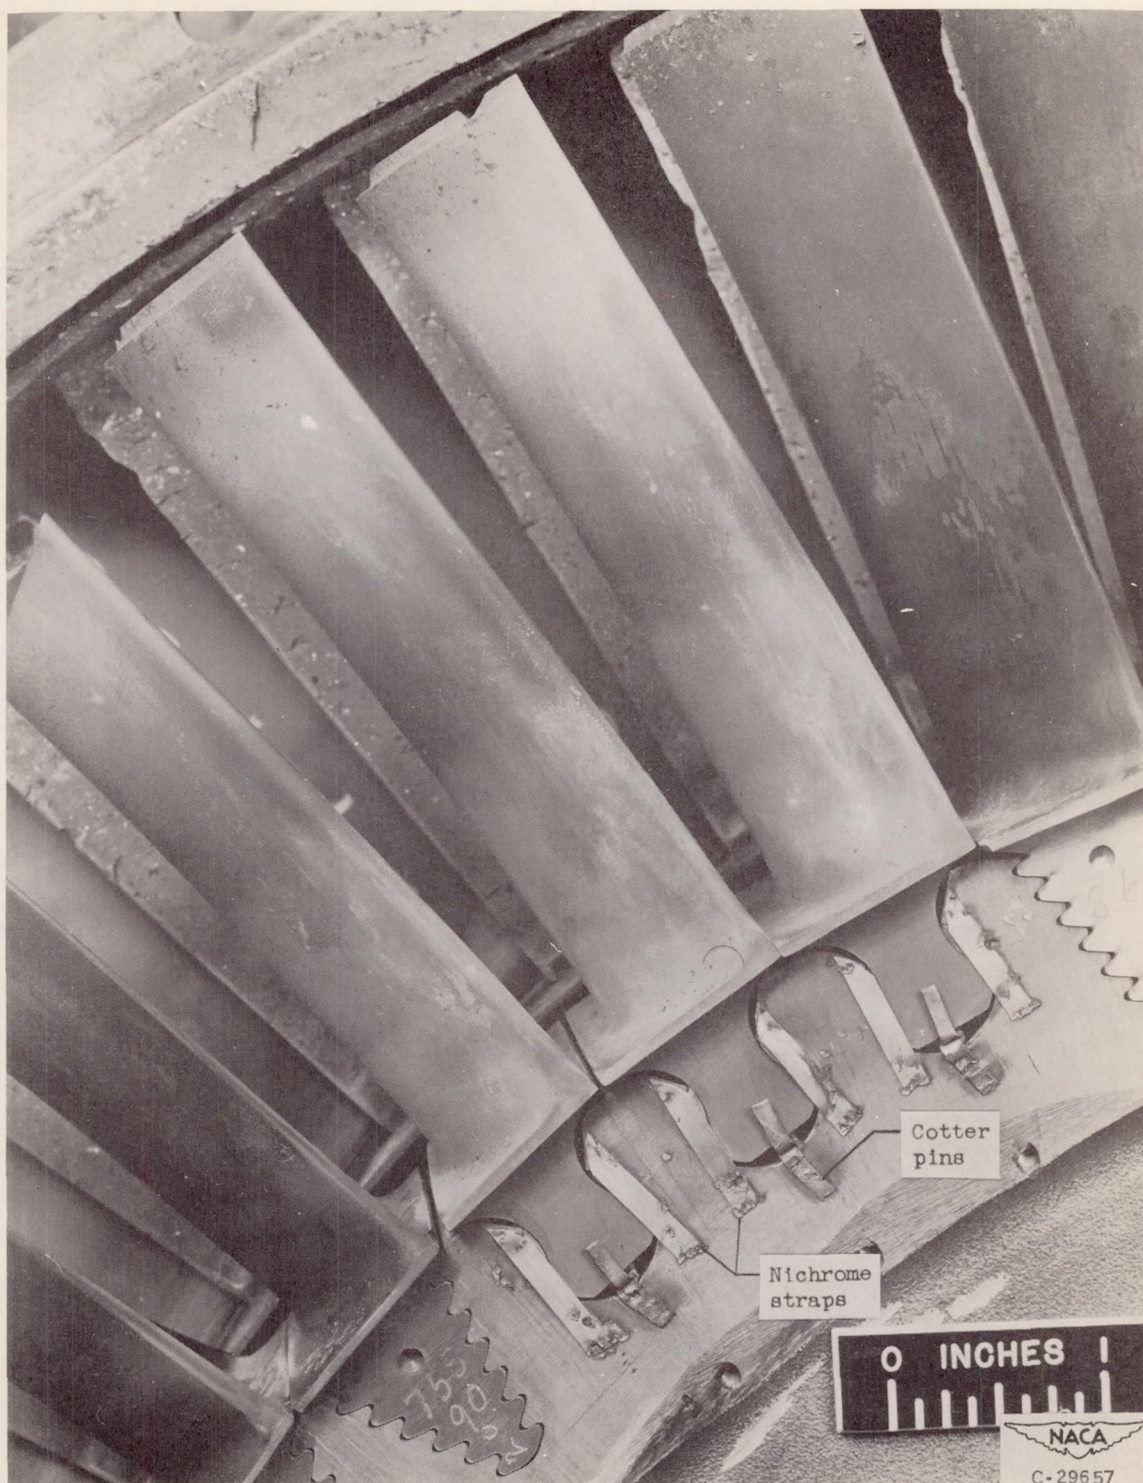
Figure 8. - Damage to ceramal turbine blades (interlock root) caused by fragments of failed ceramal turbine blade.

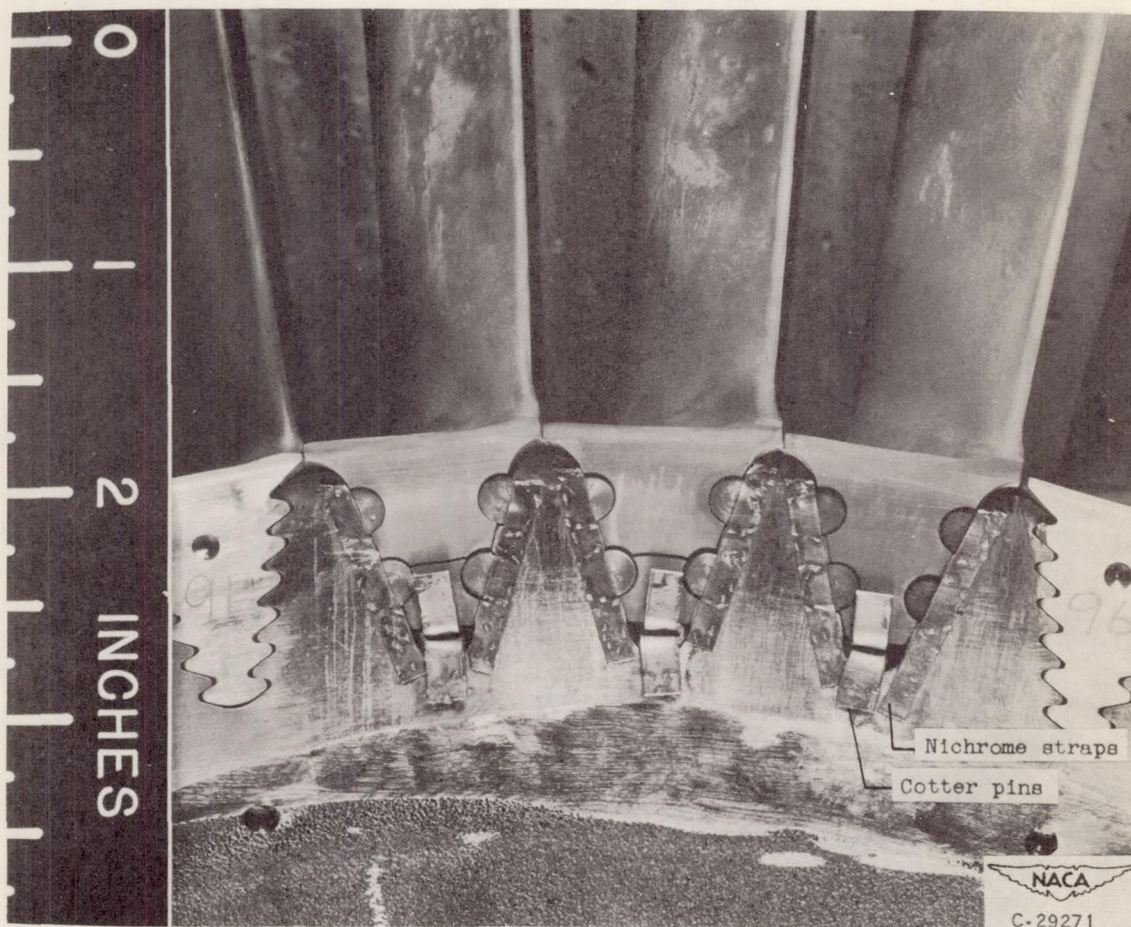
engine failed, necessitating that the engine be slowed to idle speed as rapidly as possible. After 9 hours and 42 minutes of operation (7 hr and 9 min of operation at rated conditions), the blades were all in good condition. After 19 hours and 42 minutes of operation (16 hr and 8 min at rated speed), two out of the three blades in one cluster and one out of the three blades in the other cluster were fractured across the bottom two retaining pins (fig. 10). The time these failures occurred is unknown; it appeared probable that the blade had been running in this failed condition for several hours. As the cotter pins were no longer effective in restraining the blades, a sheetmetal strap was installed across the top row of pins and operation was continued (fig. 11).

Figure 10. - Failure of ceramal blade having 4-pin root after 18 hours and 8 minutes of operation at rated speed.

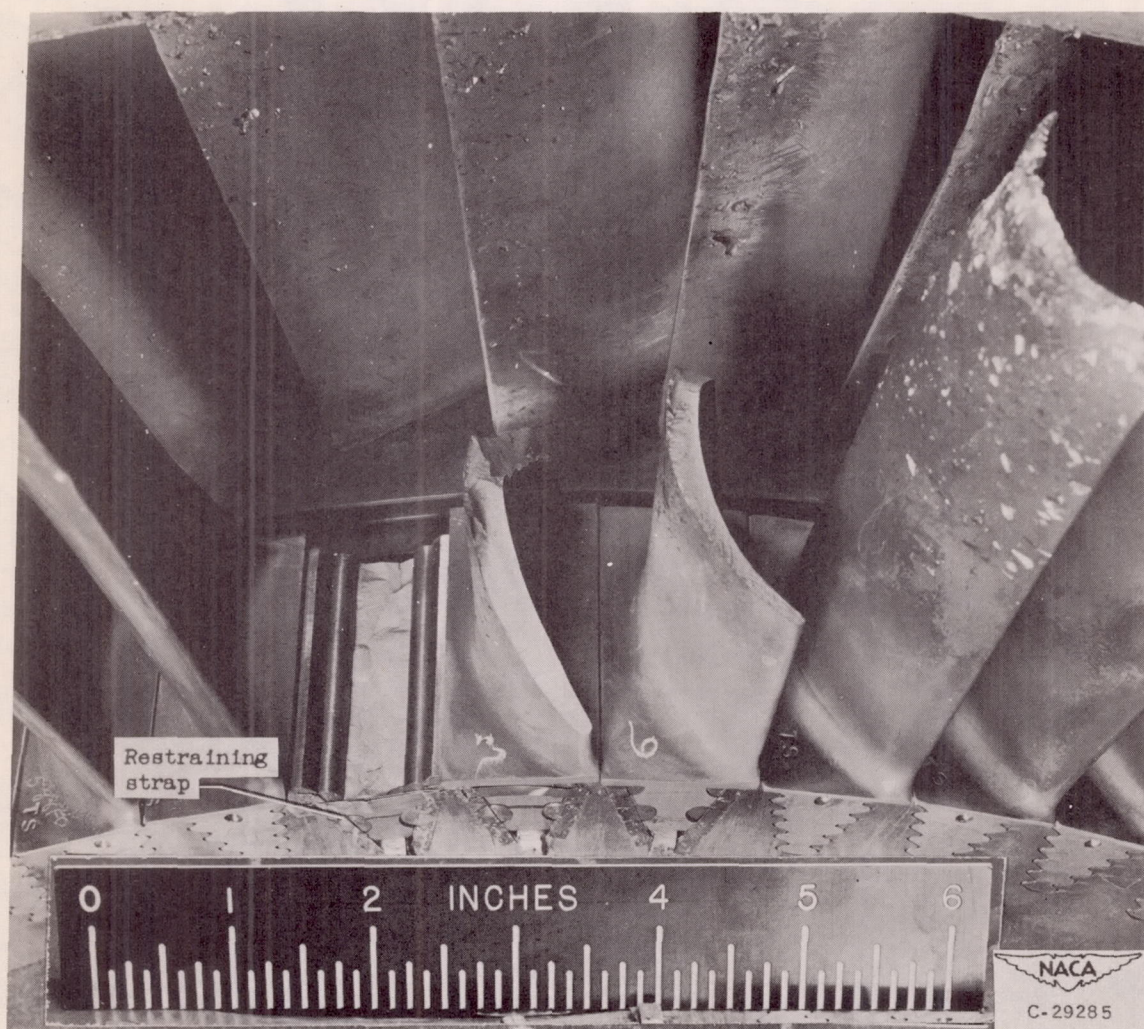
After 20 hours and 30 minutes at rated speed one blade failed across the top two pins and the fragments damaged the remaining 5 blades (fig. 8(b)). As in run 7, inspection during engine disassembly showed that several of the combustion-chamber-liner retaining pins had failed and that there had been severe damage to the aft end of the engine.

Again deformation was noted in the blade retaining pins. This deformation was slight and a softer pin material might prove more beneficial.

Figure 11. - Failure of ceramal blade having 4-pin root after 20 hours and 30 minutes of operation at rated speed.

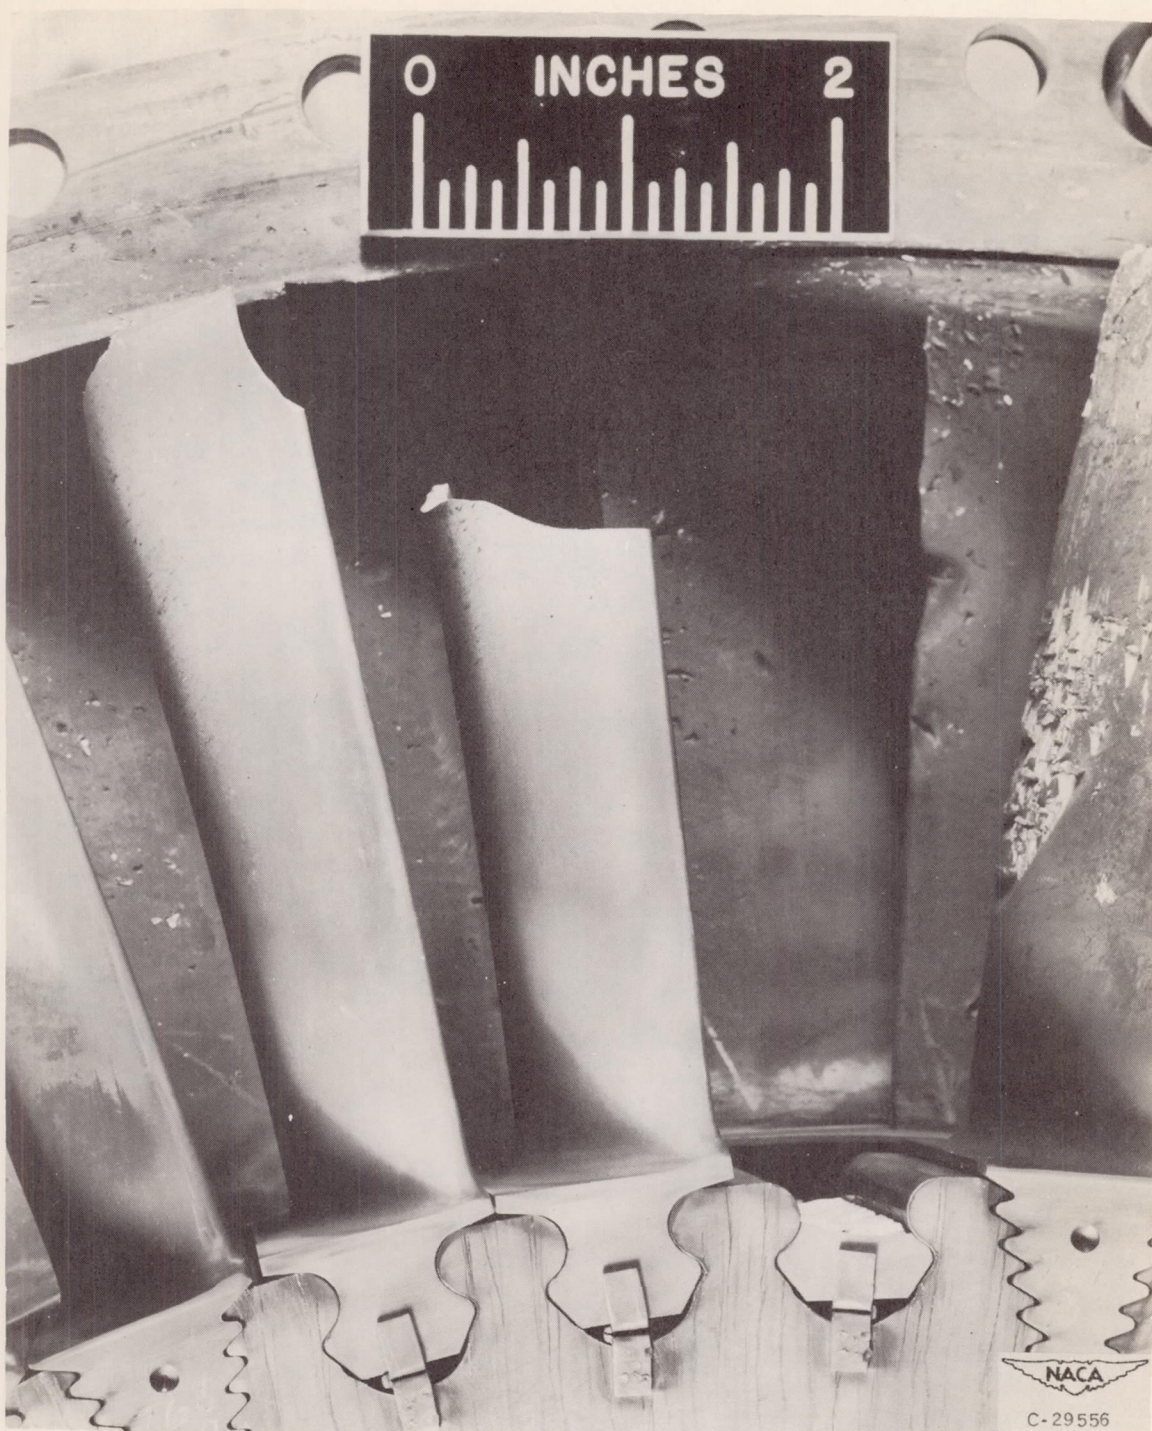
Dovetail run. - In this run mechanical failure of engine accessories necessitated three emergency shutdowns. These did not result in visible damage to the blades. After 58 hours and 28 minutes of operation at rated speed, one blade failed across the root (fig. 9) and damaged both the adjacent ceramal blades and the ceramal blades on the opposite side of the wheel, as well as several alloy blades (fig. 10). An enlarged view of this failed root is shown in figure 11. From the impression of the screen on the blade, it is evident that the screen was plastically deformed during the test. A sharp line of contact between the screen and the root can be noted in the figure. The cracks appear to follow this line. The stress concentration which caused the failure may have existed in this area.

Figure 12. - Failure of ceramal turbine blades having dovetail roots after 5 hours and 28 minutes at rated speed.

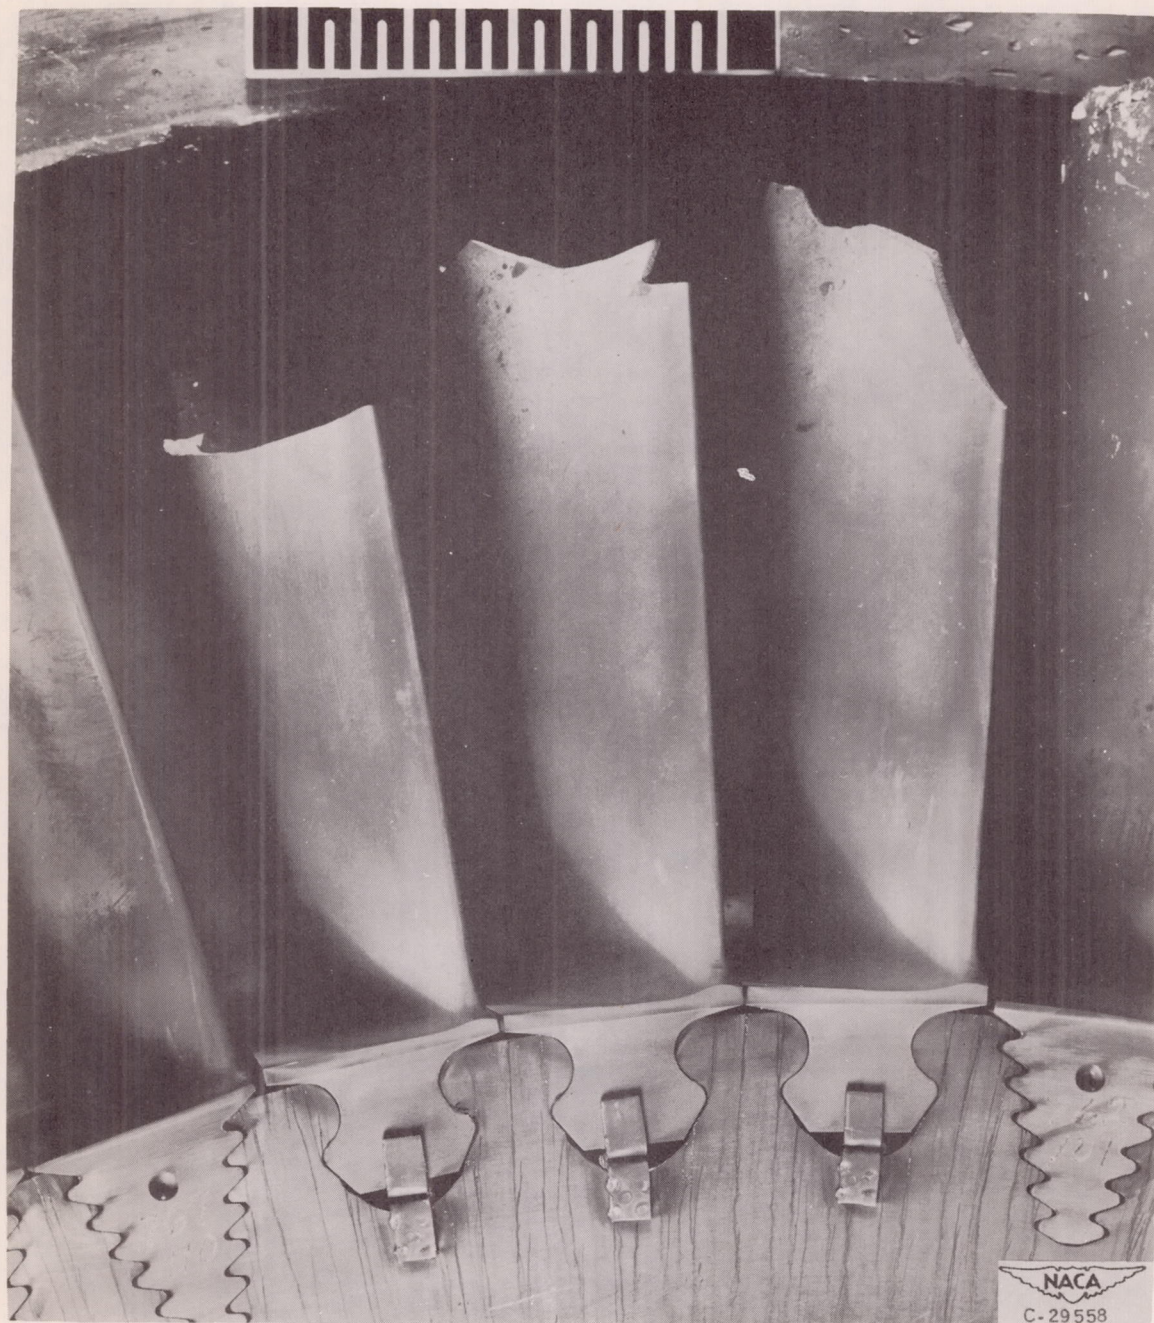
The mechanical impact of failed blade fragments in most cases only chipped the remaining ceramal blades. Whether this chipping is more detrimental to continued operation than the disturbance to the air flow caused by the distorted alloy blades that result from an alloy blade failure is not known; however, the runs indicate that the blades have a considerable amount of toughness at elevated temperatures.

Figure 13. - Damage to ceramal turbine blades (dovetail root) caused by fragments of failed ceramal turbine blades.

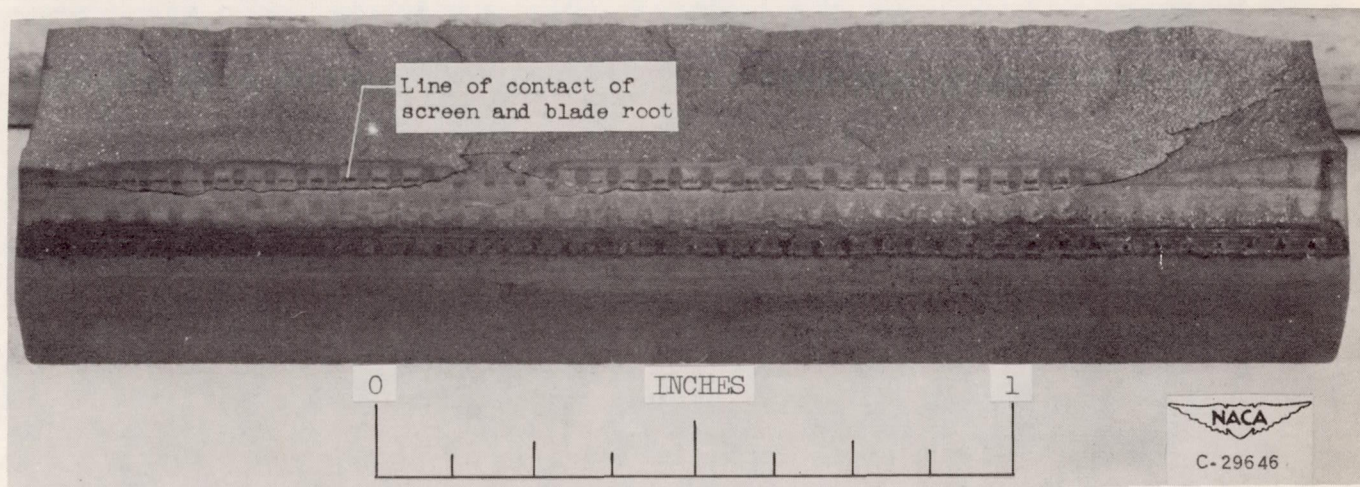
Figure 14. - Enlarged view of fragment of dovetail root of failed ceramic turbine blade.
